## **NAVAL AIR ENGINEERING CENTER**

REPORT NAEC-92-163

### **WEAR PARTICLE ATLAS (REVISED)**

Final Technical Report  
AIRTASK A03V3400/051B/Z=41460000

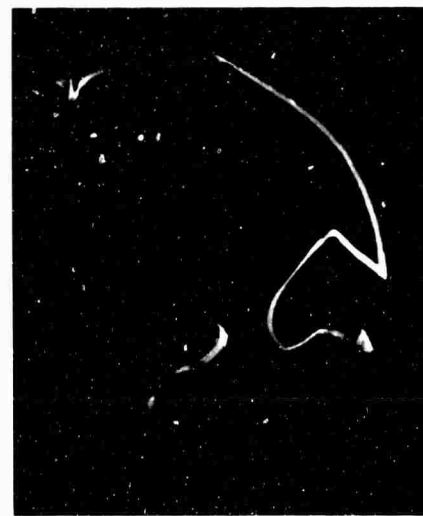
Fig. 1.2.15 S.E.M. 1000X —20μm—

**Figures 1.2.15 through 1.2.18** are SEM micrographs of a selection of cutting wear particles.

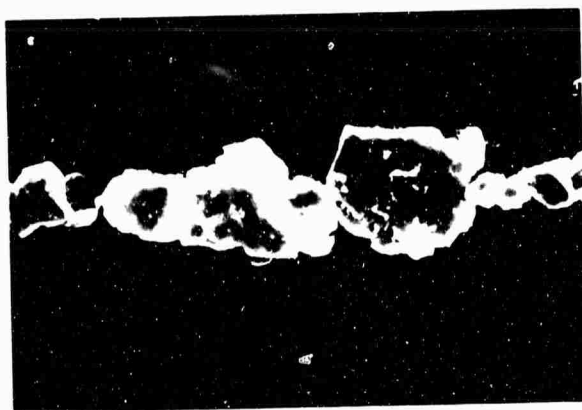
Fig. 1.3.5 S.E.M. 1000X  $\text{---}20\mu\text{m}\text{---}$

**Figures 1.3.2 through 1.3.5** display in increasing magnification particles generated by rolling-element bearing fatigue spalls. Note the smooth surfaces and irregular contours. Also, what appear to be micropits on the particle surfaces in the optical micrograph are in fact smaller pieces of wear debris.

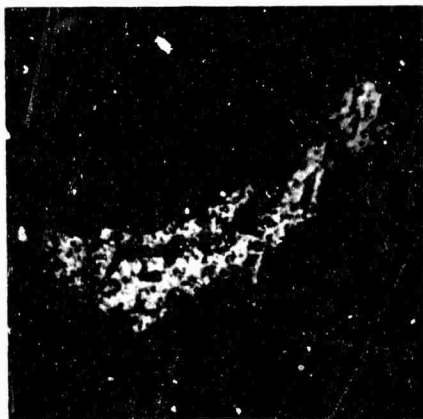
Fig. 1.3.9 Opt. M. 450X  $\text{—} 50\mu\text{m} \text{—}$

**Figures 1.3.9 and 1.3.10** display the irregular shape and size of a particle that rolling-element fatigue can generate.

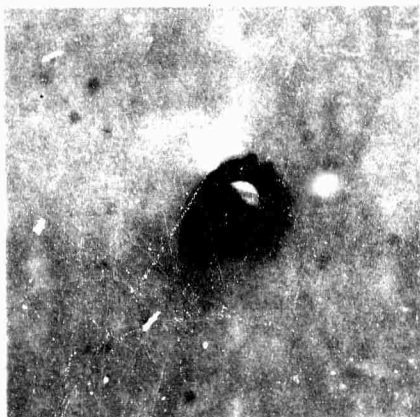
Fig. 1.3.12 Opt. M. 1000X  $\text{—} 20\mu\text{m} \text{—}$

**Figures 1.3.11 through 1.3.13** are photographs of metallic spheres. They are much larger than the spheres normally generated by bearing fatigue. These spheres may be from an extraneous source. However, they serve the purpose of displaying the optical characteristics of these spheres. The curvature of the sphere causes light from above

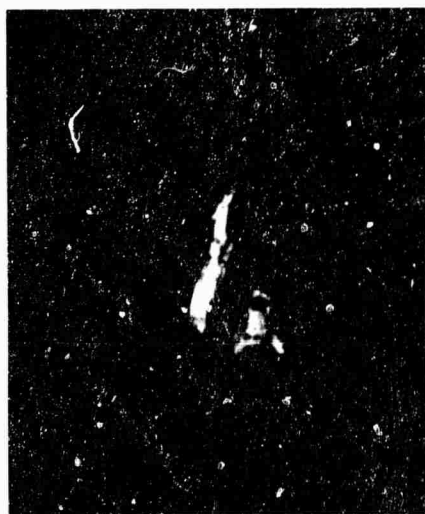
Fig. 1.4.15 Opt. M. 1000X

**Figures 1.4.15 through 1.4.17** are individual scuffing wear particles. The dark parts on the particles in these optical photographs are the result of oxidation.

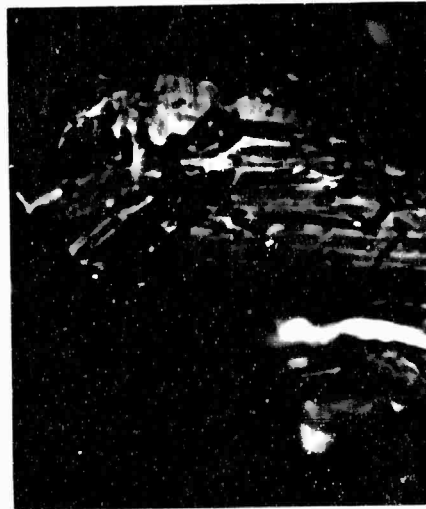
Fig. 1.5.6 Opt. M. 1000X 20 $\mu$ m

**Figures 1.5.5 through 1.5.7** are optical micrographs of individual severe sliding wear particles. The particle in **Figure 1.5.7** shows colors caused by surface heating resulting from a high sliding speed.

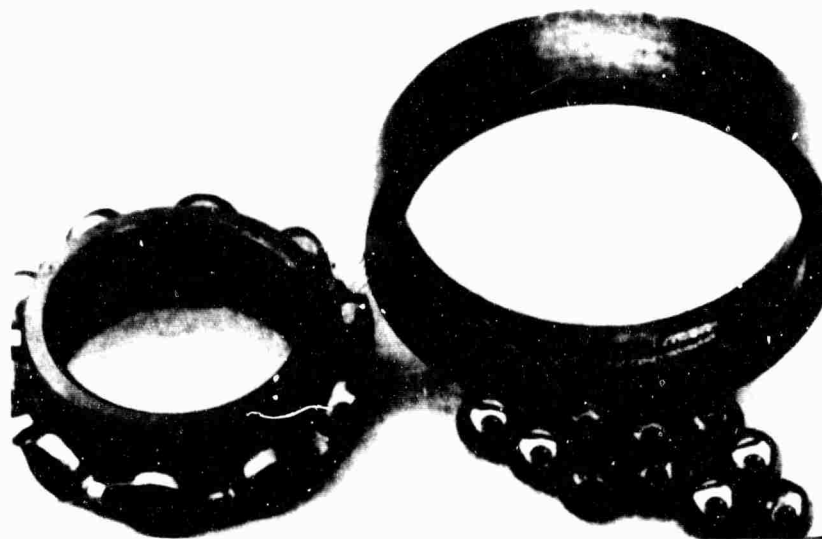
**Figure 2.2.3.13 (B & W Photo) Shaft Gear Bearing After Removal**

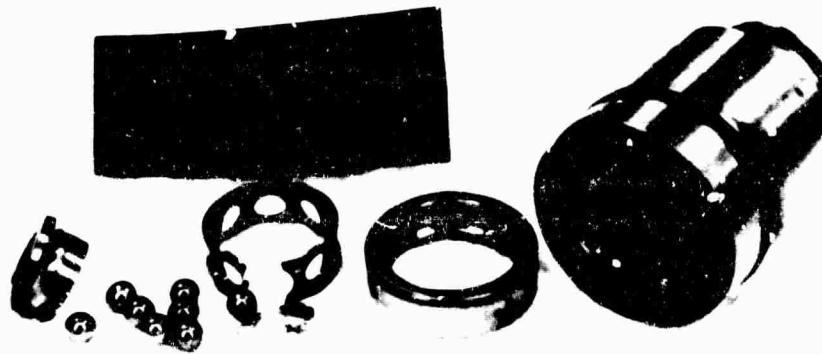
**Figure 2.2.3.26 (B & W Photo) Failed Bearing**

Although some laminar particles are present, most of the particles are too thick to be so classified and should be categorized as severe wear particles. Notice on **Figure 2.2.3.24** the background is out of focus, indicating that the large severe wear particles are at least several micrometers thick. **Figure 2.2.3.25** shows a 1000x magnification view of some of these severe wear particles. Plenty of blue and straw temper color as well as some dark metallo-oxides are present, attesting to high heat and/or lubricant starvation during particle generation. **Figure 2.2.3.26** shows the failed bearing assembly which appears to be grossly spalled although the underlying cause for this failure is not known.

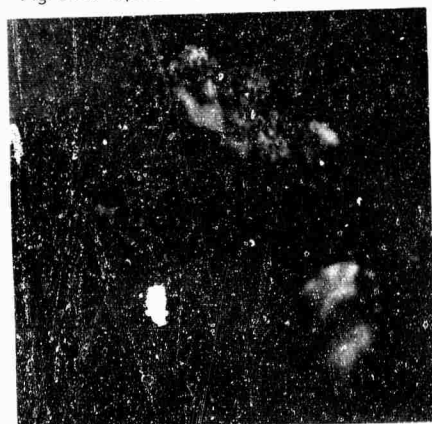
Fig 2.7.1 Opt. M. 1000X | 20 $\mu$ m |

**Figure 2.7.1** shows some of these particles near the entry at 1000x magnification. Cracks in the particles are not unidirectional, which is consistent with the equiaxed or chunky shape of the particles. In terms of reporting, these particles are classified as dark metallo-oxides and as fatigue chunks since they fit either category. Quite a bit of red oxide is also present, and that category must be included as well. **Figure 2.7.2** shows a black oxide particle with gold adhered to it. Observe how cracks run in several different directions across and into the particle. **Figure 2.7.3** is the same view as seen by the SEM. **Figure 2.7.4** shows some of these fretting wear particles in polarized reflected light which highlights the oxide coating which is a non-stoichiometric compound. See paragraph 1.7 on Ferrous Oxides. Another characteristic of these particles is that the small particles look identical to the larger particles, which is an indication that they are all produced by the same wear mechanism.

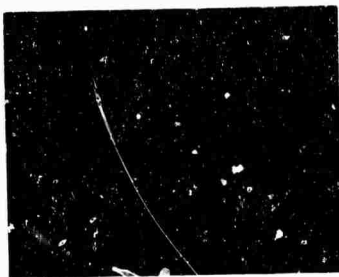
PHOTO NO. P0355-2 DATE 5/22/80  
MAGNIFICATION: 175x  
LOCATION ON FERROGRAM: entry  
SAMPLE IDENTIFICATION:  
OPERATING HISTORY:  
48 hours  
REMARKS:  
Narrow view of the entry deposit shows particles similar to those in the 24-hour sample except that the concentration is lower.

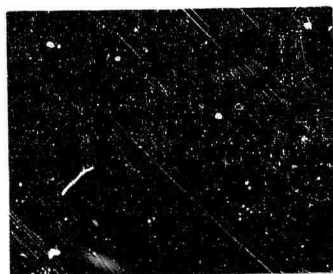
PHOTO NO. 1016-2 DATE 5/10/80  
MAGNIFICATION 100X  
LOCATION ON  
FERRUGAN  
SAMPLE IDENTIFICATION  
OPERATING HISTORY  
REMARKS  
Retained micrograph of the same  
view as above highlighting the  
white metal particles and  
oxidized iron particles
